Shenzhen Center for Analysis and Measurement of Material Surface

Test Report

Report No.: SAC2017-05028E

Sample Name : FLEX LED NEON

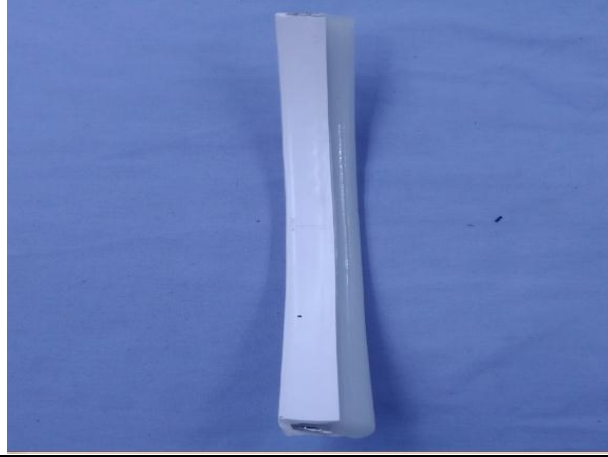
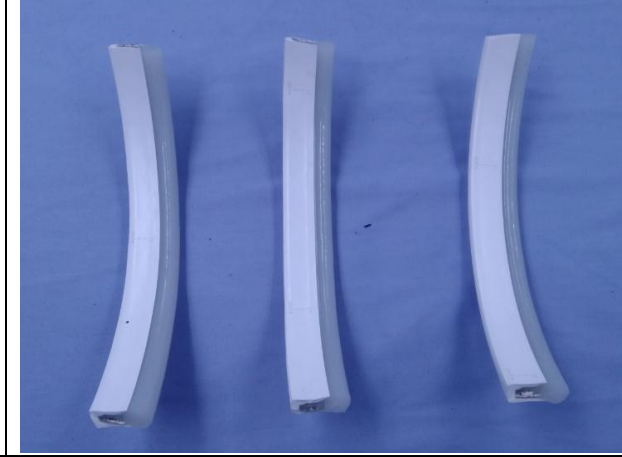
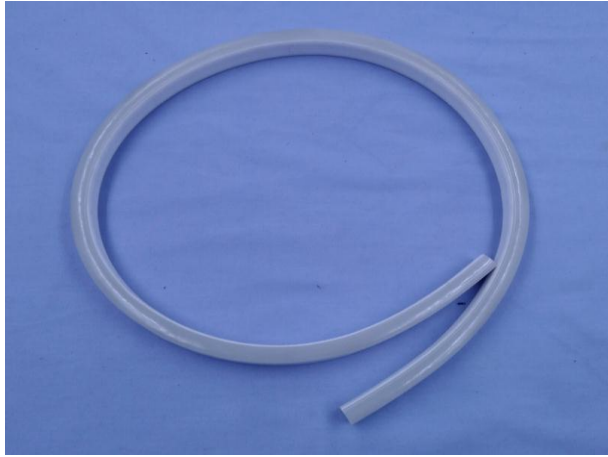
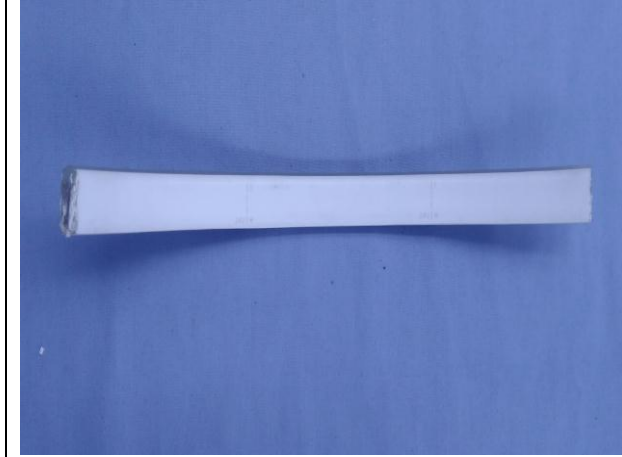
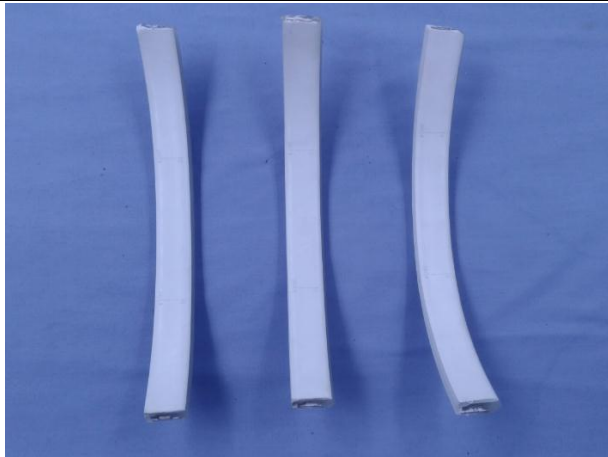
The representative appearance photo of the samples before the test was shown in Fig.1.

<p>/</p>
<p>3-1#~3-3#</p>	<p>/</p>
<p>Fig.1. The representative appearance photo of the samples before the test</p>

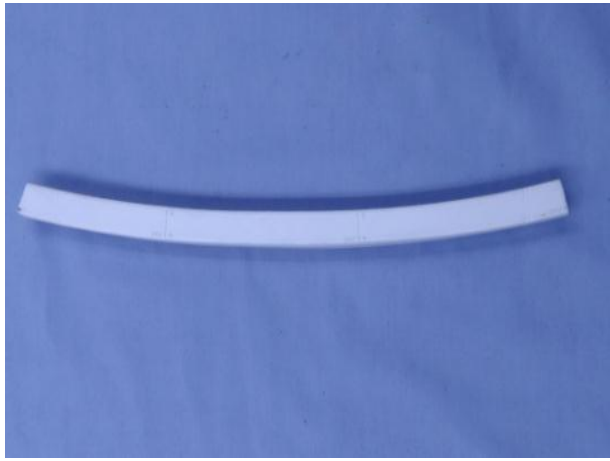
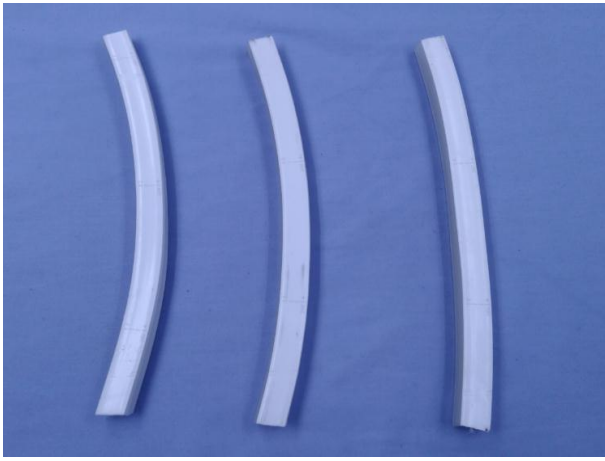
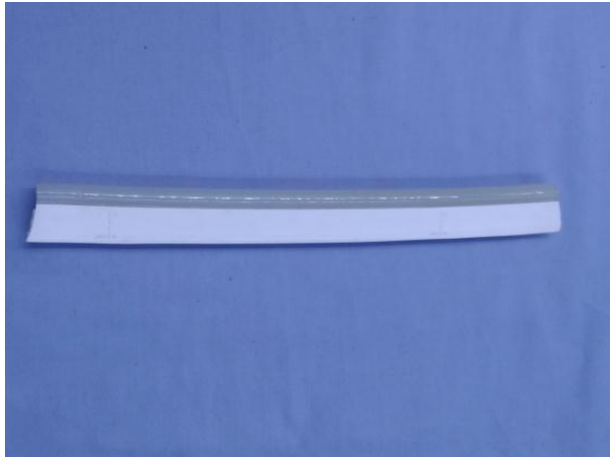
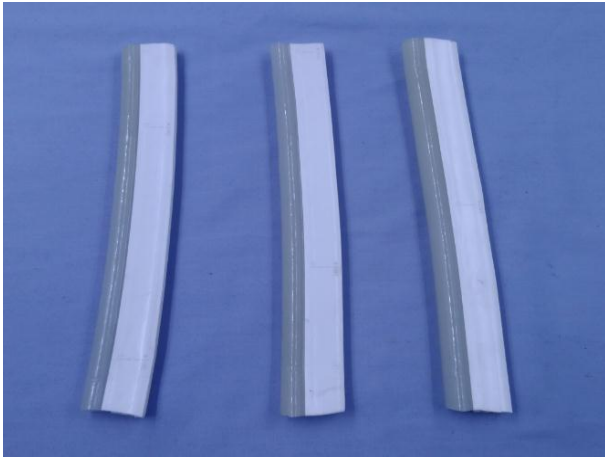
4. Photos of the samples after the test

Test Time	Sample No.	Test Results
48h	1-1#~3-3#	Visual inspection, no change color found on the surface of the samples.
